Reconstruction of the Buffalo Creek and Gauley Rail Trail

Presented By: Kenneth Kinder
WV Floodplain Managers Conference
May 16, 2023

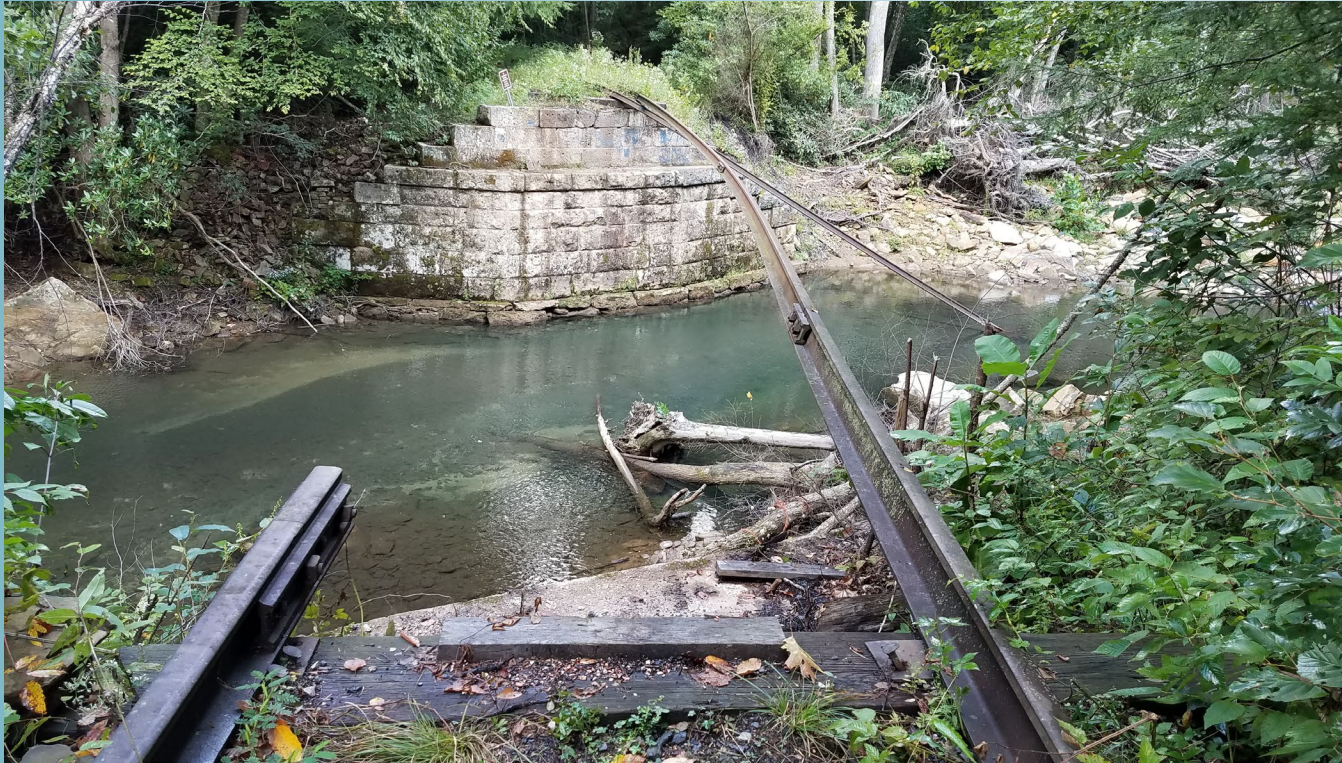
Mine War Bridge

- ~15 mi. upstream of confluence
- Displaced center pier and girders
- One girder carried ~ 100 yards downstream

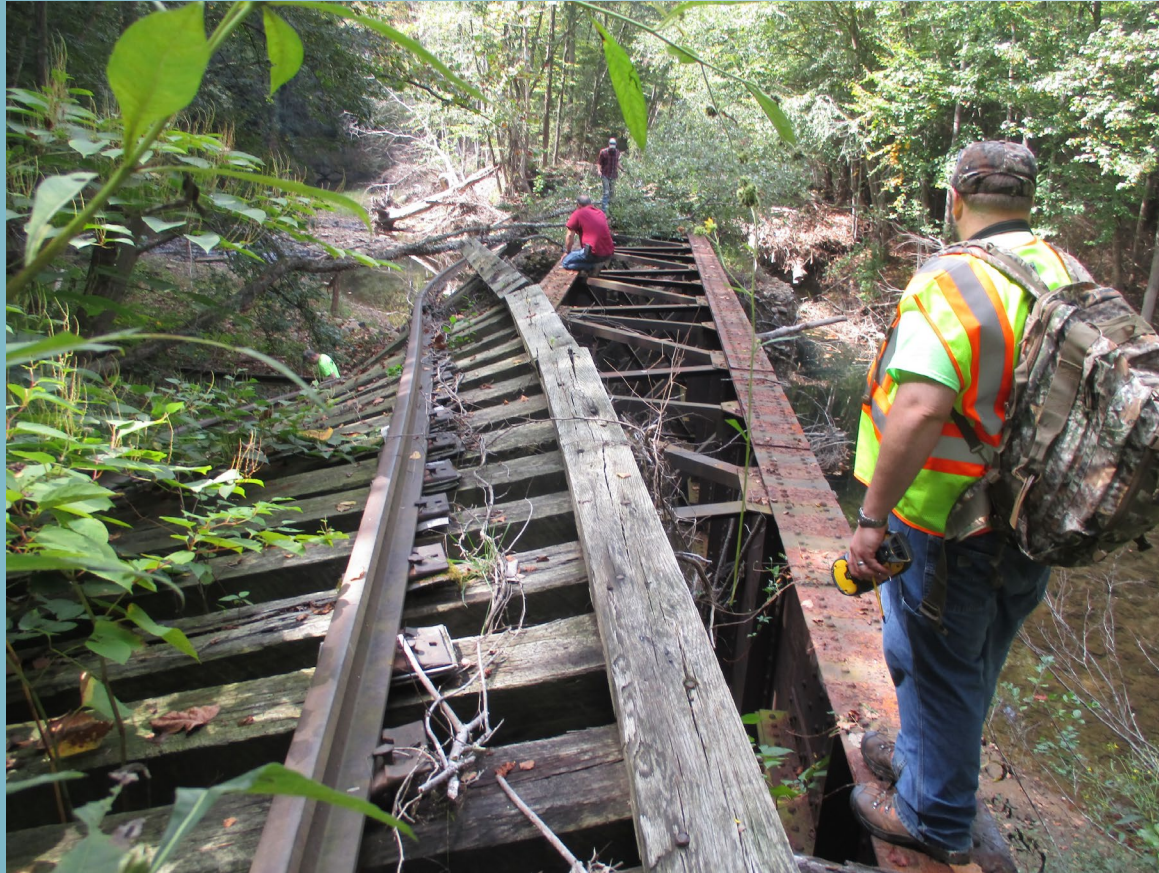
Sand Fork Bridge

- Track displaced from rail alignment for hundreds of feet
- Displaced girder section

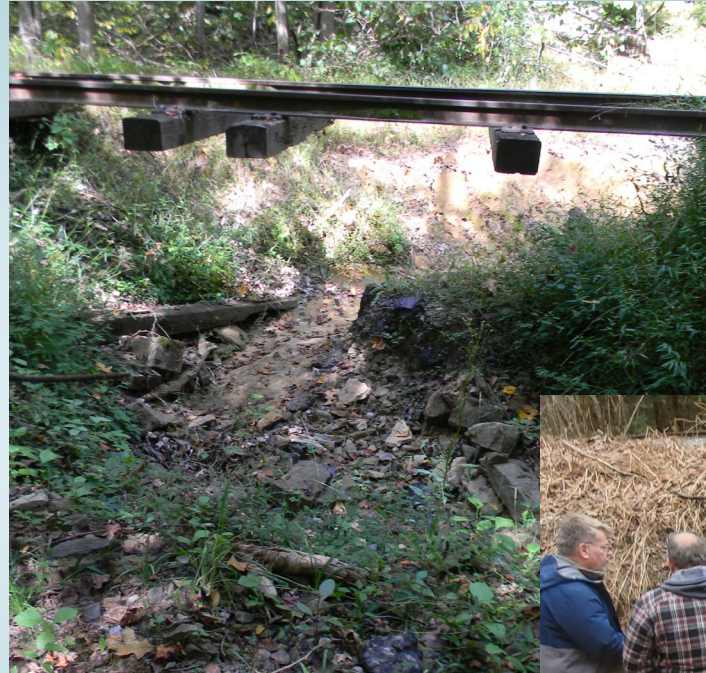
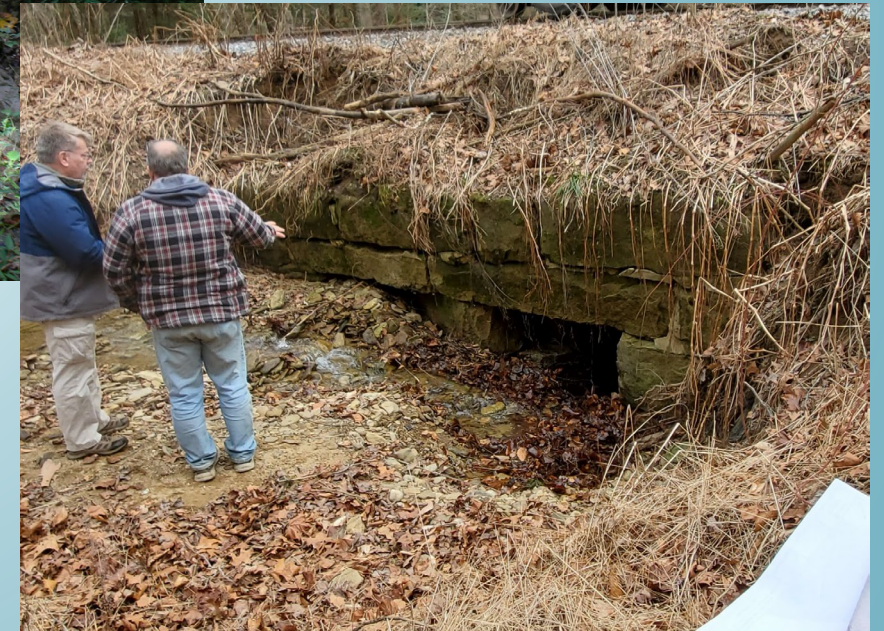
- **Culvert Assessments**

- Many culverts were found to be plugged, needing jetted
- H&H analyses performed at various culverts to justify increasing the size through HMP.
- Several culverts were completely washed away from the track

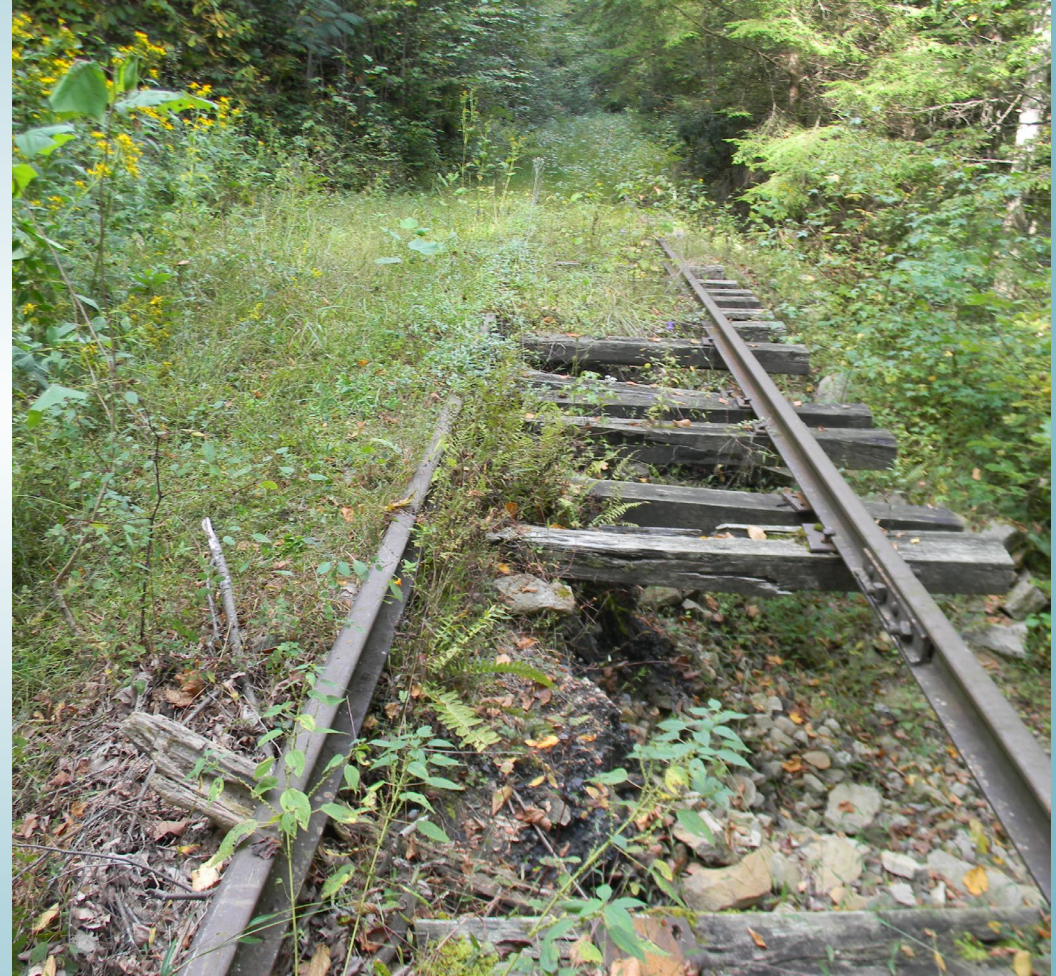
- **Slope Failure Sites**

- Loss of embankment due to erosion and scour
- Difficult to repair due to topographic constraints
- Required geotechnical evaluations
- Repair methods proposed gabion walls or riprap slope protection

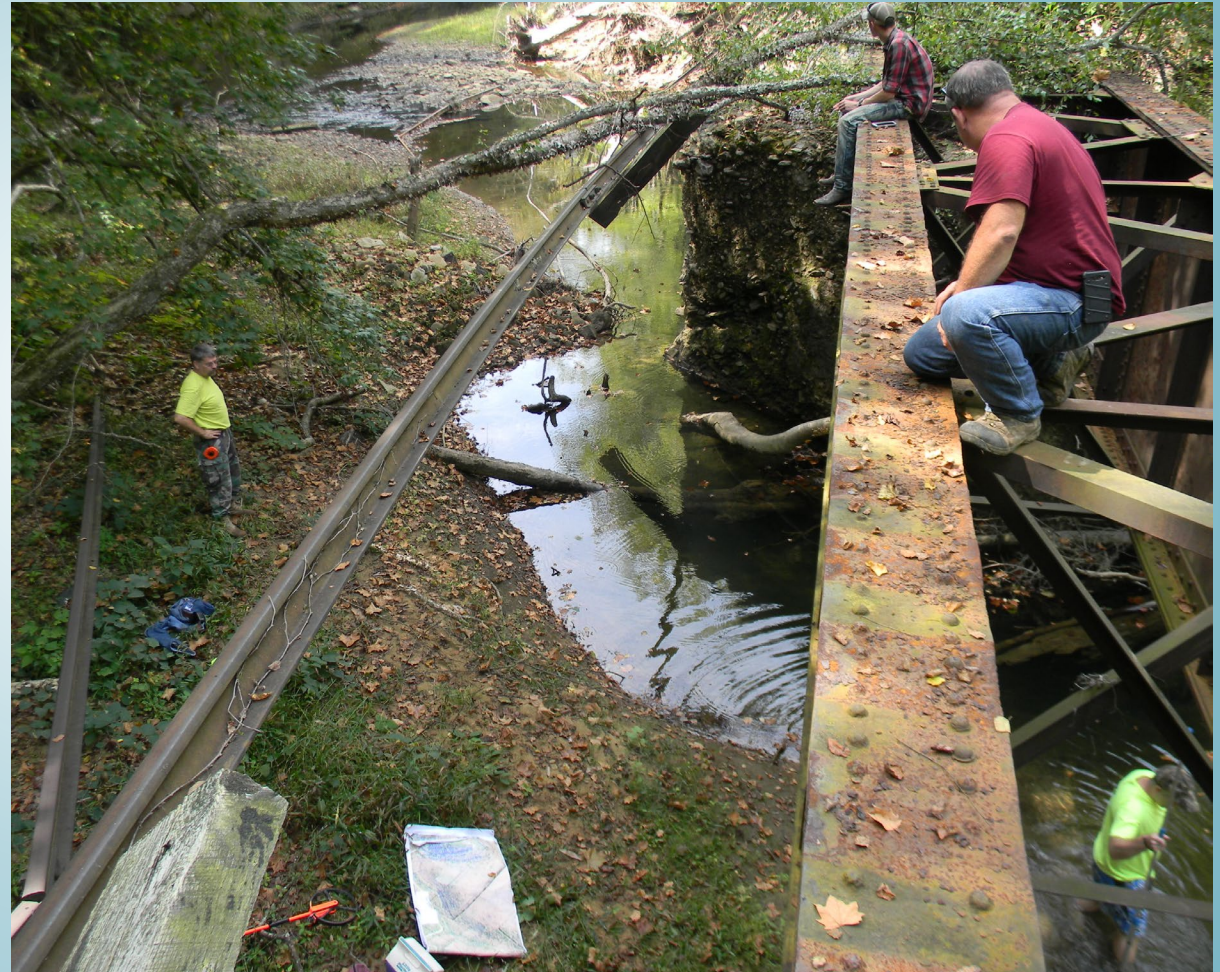
- **Bridge Sites**

- Scour assessments
- Construction accessibility limitations
- SHPO requirements
- What load rating?
- Value engineering
